Tamar Estuary
and Esk Rivers

TAMAR ESTUARY 2018 REPORT CARD

ECOSYSTEM HEALTH ASSESSMENT PROGRAM
MONITORING PERIOD DECEMBER 2016 – NOVEMBER 2017

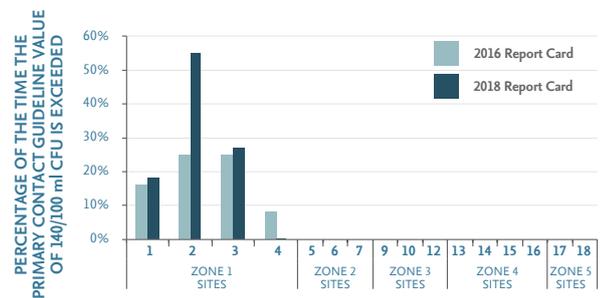
During 2017, there were no instances of levels exceeding the primary contact limit (<140/100ml) outside of zone 1 (Figure 2). In zone 1, the limit was exceeded in January and from May to September, following rainfall events. The pathogen levels in zone 1 for the 2018 report card period have increased in comparison to the 2016 report card period, particularly at site 2 near Kings Wharf.

FIGURE 2. EXCEEDANCE OF PRIMARY CONTACT RECREATIONAL GUIDELINE

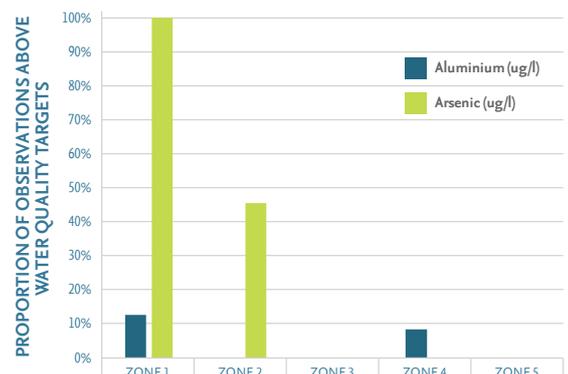
Figure 3 shows the observations of different metals in each zone which exceeded water quality targets. Zones 3 and 5 are within targets for all metals 100% of the time. Observations of lead, cadmium, copper and zinc did not exceed targets in any zone. Zone 4 has all metals within targets except aluminium which exceeds targets for less than 10% of observations. Zone 2 is within targets for all pollutants except arsenic which fails to meet the target for 45% of observations.

Zone 1 is known to have a history of metal contamination due to the direct input of pollutants from urban areas, sewage treatment plants and historic mining. The strong incoming tide traps pollutants in this zone. In zone 1, aluminium fails to meet the target for approximately 10% of observations and arsenic exceeds the target for all observations.

FIGURE 3: PROPORTION OF METAL OBSERVATIONS EXCEEDING WATER QUALITY TARGETS ACROSS ALL ZONES IN THE TAMAR RIVER IN 2017

Note: Observations of lead, cadmium, copper and zinc did not exceed the water quality targets for metals in any zone and have therefore not been included in Figure 3.

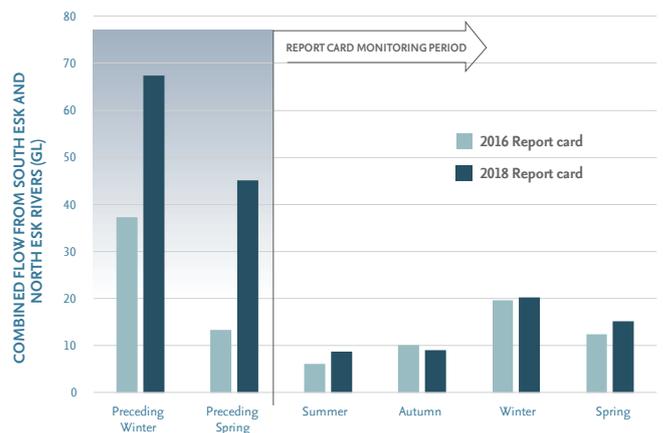
The 2016 extreme wet conditions delivered high levels of pollutants to the estuary preceding the collection of 2018 report card data (Figure 5). Due to the strong tidal nature of the Tamar, many of these pollutants remained trapped in the estuary. Increased algal growth (measured by chlorophyll-a) and consequently, a drop in dissolved oxygen, were likely to have been influenced by the combination of the wet winter delivering high pollutant loads followed by a warm and dry summer and autumn, with lower river flows and warmer water temperatures. This is consistent with the pattern of increasing chlorophyll-a and declining dissolved oxygen observed in the 2018 report card monitoring period, driving the change in ecosystem health grades.

FIGURE 5. MONTHLY FLOW PRECEDING AND DURING THE REPORT CARD PERIOD

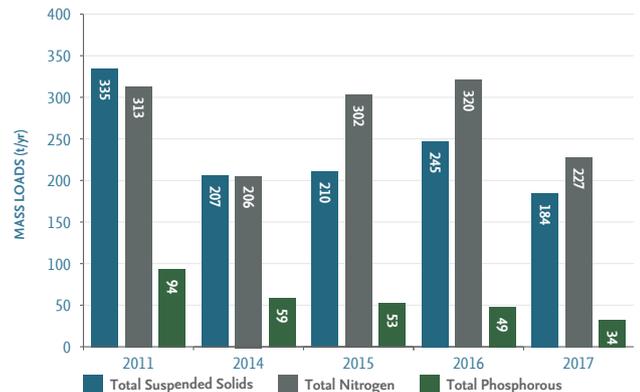
Figure 6 shows the nutrient (total nitrogen and phosphorous) and sediment (total suspended solids) loads estimated to have been discharged to the Tamar River estuary from 2011 to 2017.

The elevated discharge loads in 2016 are likely due to the increased rainfall in 2016, which led to increased volumes of water passing through STPs (eg. stormwater entering sewerage infrastructure through manholes) and a reduced demand for reuse of treated wastewater.

Elevated discharges of nitrogen in comparison to phosphorous in 2015, 2016 and 2017 may be linked to operational changes in 2015 to address odour management at the Ti-Tree Bend STP. These operational changes led to a reduction in phosphorous without a corresponding reduction in nitrogen.

FIGURE 6. ESTIMATED AVERAGE ANNUAL LOADS FROM SEWAGE TREATMENT PLANTS DISCHARGING TO THE TAMAR RIVER ESTUARY

Note: Mass loads have been calculated based on average concentration for each parameter for each month of discharge to water, then multiplied by the total flow discharged to water for 2017. Figures do not include discharge to reuse or overflows from the combined sewer-stormwater system in Launceston.

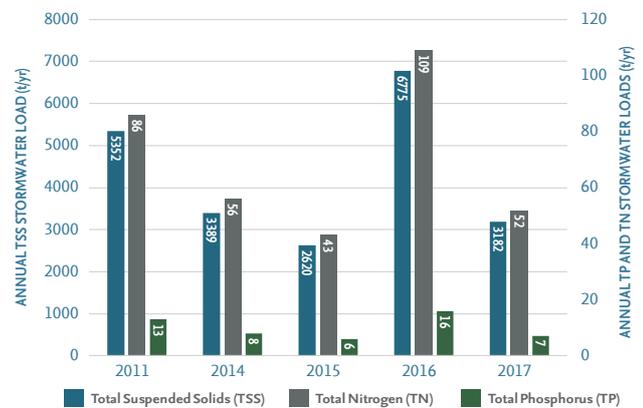
Figure 7 shows the influence of the relatively dry year in 2017. Stormwater pollutant loads correlate to intensity and duration of rainfall, less rainfall leads to smaller pollutant loads. Average rainfall in 2017 has resulted in less run-off from urban and rural land areas and consequently less pollutant loads entering the estuary in comparison to the exceptionally wet years in 2016 and 2011.

FIGURE 7. ESTIMATED ANNUAL STORMWATER LOADS TO THE TAMAR RIVER ESTUARY

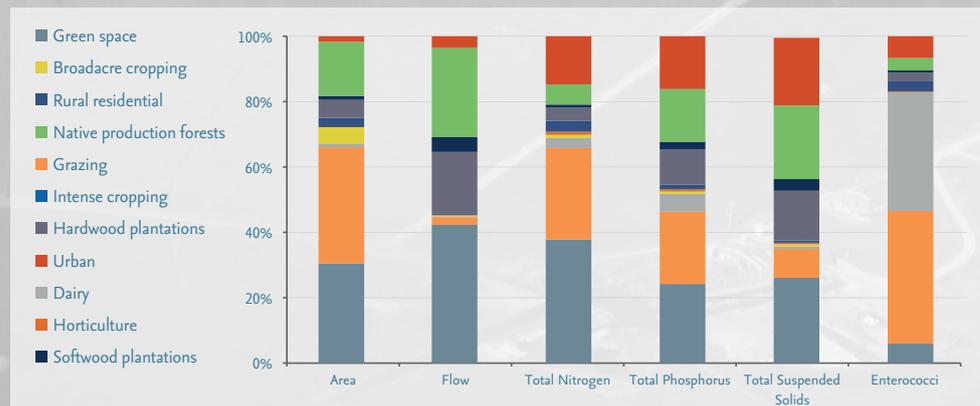
Land cover is a significant factor that contributes to the volume of surface runoff, however slope and rainfall are also important contributing factors. For this reason it is important to compare the relative load contribution of land uses not only to their relative area but also to the flows they produce as this is a major driver of pollutant loads, with higher flows contributing higher pollutant loads all other things being equal.

FIGURE 2. ESTIMATED DIFFUSE POLLUTANT LOADS AND FLOW VERSUS LAND USE AREA

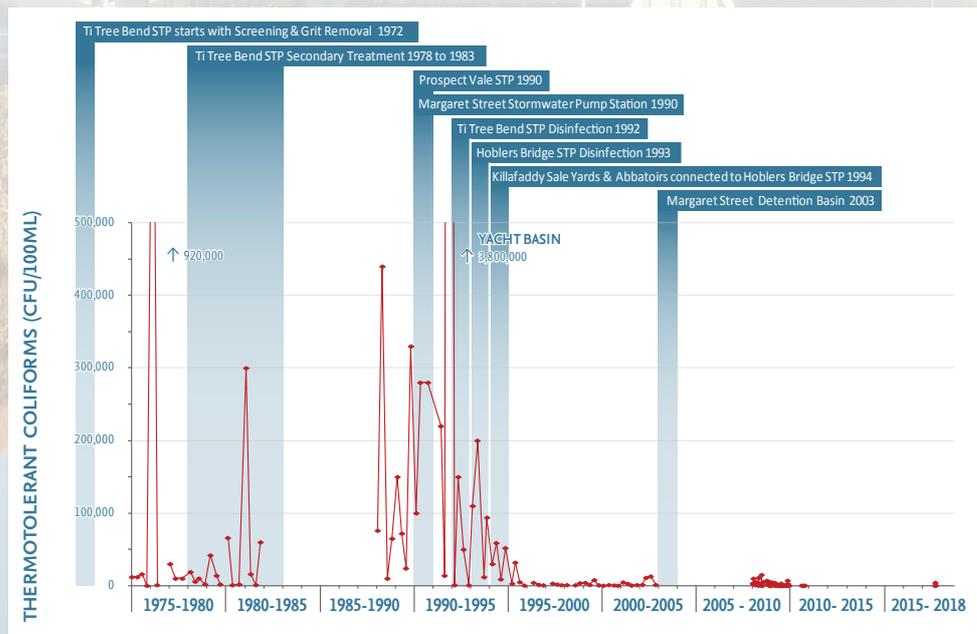
From the early 1990s through to 2000s, levels of bacteria were greatly reduced. Improvements in water quality in the upper estuary occurred as a result of improved treatment at STPs, redirection of trade-waste to STPs and upgrades to the combined sewage and stormwater system which reduced overflows from Margaret Street.

Recent levels of bacteria in the Tamar estuary have all been <500 showing a large improvement from years gone by. The last large spikes in bacterial concentrations occurred just before Killafaddy sale yards and abattoir were connected to the Hoblers Bridge STP.

FIGURE 1. HISTORICAL PATHOGEN CONCENTRATIONS IN THE UPPER TAMAR (COLONY FORMING UNITS PER 100ML) (SOURCE: CITY OF LAUNCESTON PROVIDED TO THE TEM FOR THE RIVER HEALTH ACTION PLAN)

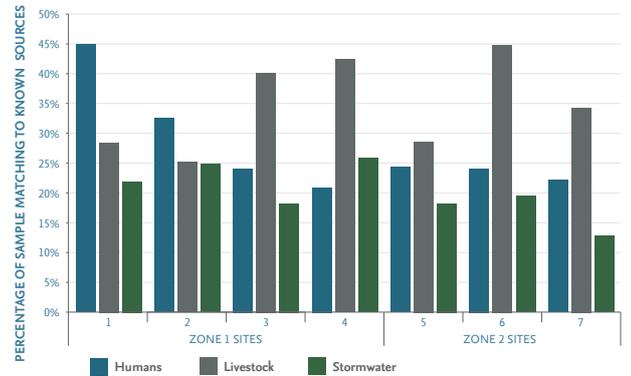
Faecal source tracking is a method of identifying the source of bacteria in a water body through the unique strains of bacteria known to be associated with different human and animal sources. Throughout 2017, water samples were tested for the main contributing sources of bacteria at 10 sites in zones 1, 2 and 3. Levels of bacteria were too low to give an indication of sources beyond mid zone 2. Data showed that the main contributors (20-40%) of the bacteria identified in zones 1 and 2 are livestock (sheep, cattle and horses) and to a lesser extent, humans (sewage treatment plants and septic tanks). The area from Kings Bridge to the ship lift at Kings Wharf tended to be dominated by bacteria from sewage treatment plants (20-30%). This transitions to being dominated by livestock bacteria nearer Riverside, peaking near Legana with livestock dominating at 30-40% of identified bacteria.

FIGURE 2: THE PERCENTAGE OF BACTERIA IDENTIFIED FROM KNOWN SOURCES: HUMANS (SEPTIC SYSTEMS AND SEWAGE TREATMENT PLANTS), LIVESTOCK (SHEEP, CATTLE AND HORSES) AND STORMWATER IN ZONES 1 AND 2 DURING 2017.

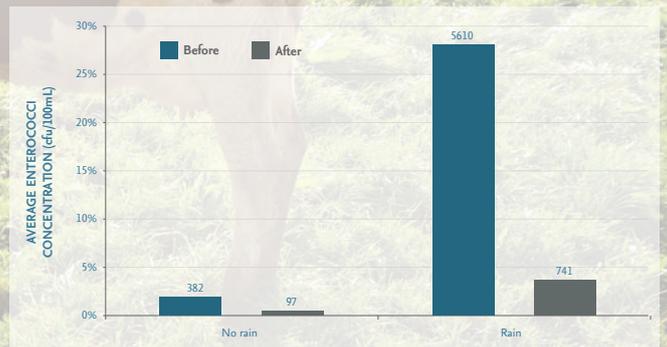
Since resolving these issues, monitoring data from Kings Meadows Rivulet shows a marked improvement in bacteria levels which modelling suggests will have benefits to water quality in zone 1 of the estuary. Figure 3 shows the average concentration of enterococci for days with and without rain, before and after works, to address pathogen contamination. This figure shows that average concentrations for days both with and without rain decreased by more than 70% after works were complete.

FIGURE 3: AVERAGE ENTEROCOCCI CONCENTRATION (CFU/100ML) FOR DAYS WITH AND WITHOUT RAIN DURING THE PERIOD BEFORE AND AFTER WORKS TO ADDRESS PATHOGEN LEVELS.
