Water Quality Improvement Plan
for Floodplain Lower Ringarooma
River Wetlands
isNRM Pty Ltd

May 2021

Citation: Kelly, R. (2021). Water Quality Improvement Plan for Floodplain Lower Ringarooma River Wetlands, Report to NRM North, isNRM Pty Ltd, May 2021.

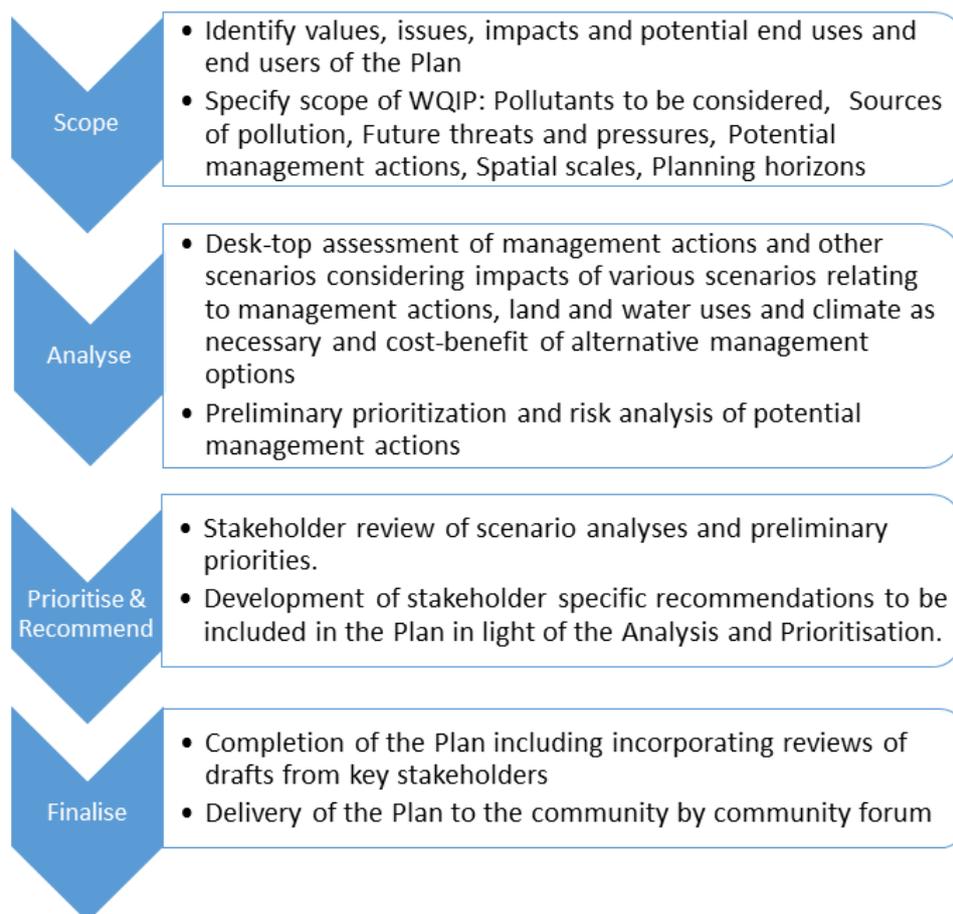
The WQIP has been developed using the four steps shown in Figure 1.

FIGURE 1. WQIP DEVELOPMENT PROCESS

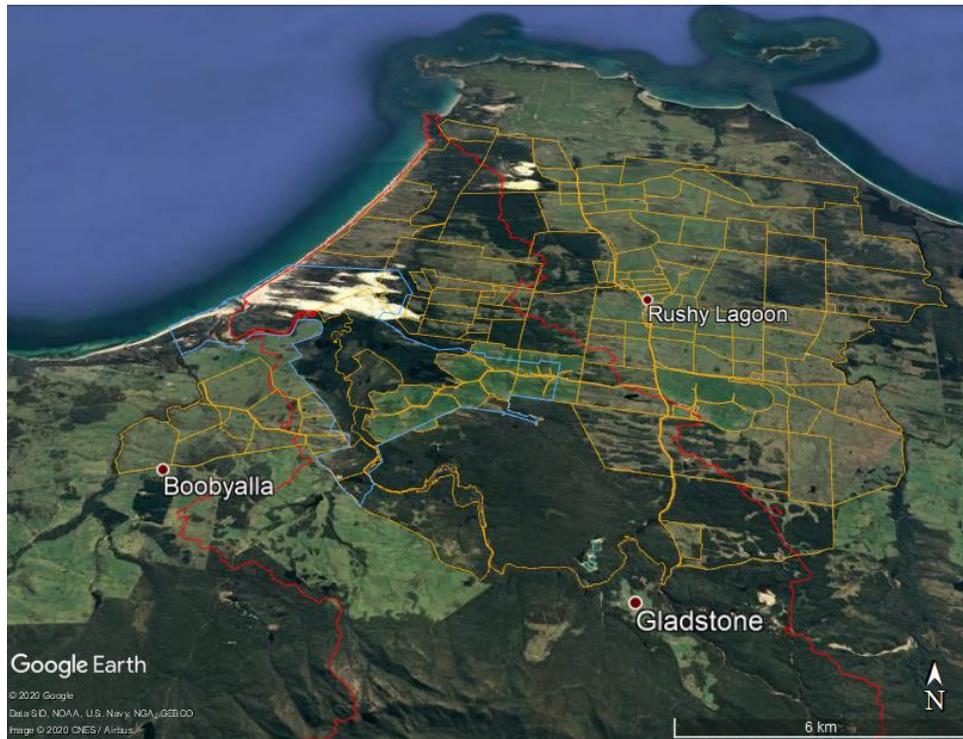
Rushy Lagoon is a large landholding comprising over 20,000ha of sheep and cattle grazing and 4 dairies. The property extends outside the catchment of the Floodplain Lower Ringarooma River Wetlands. The property boundary and catchment boundary are shown as orange and red lines respectively in Figure 19. The boundary of the Ramsar site is shown in the blue line.

FIGURE 19. RUSHY LAGOON PROPERTY BOUNDARY (ORANGE) WITH CATCHMENT (RED) AN RAMSAR SITE (BLUE) BOUNDARIES MARKED

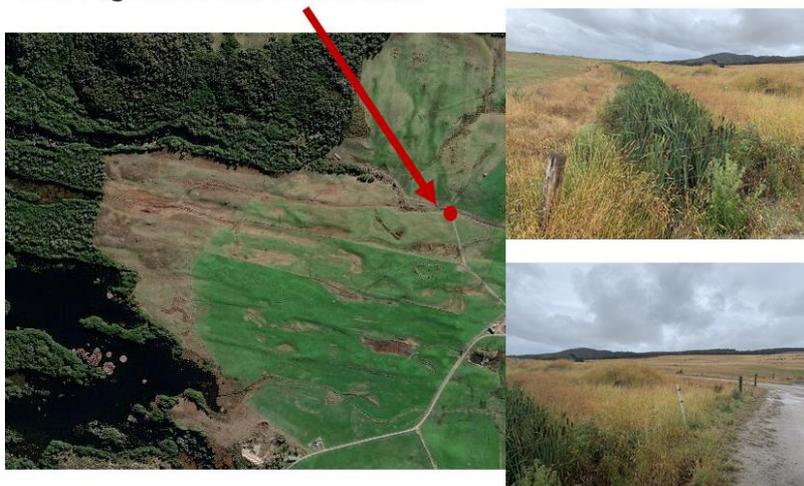
Well vegetated and fenced drain

FIGURE 24. A WELL VEGETATED AND FENCED DRAINAGE LINE

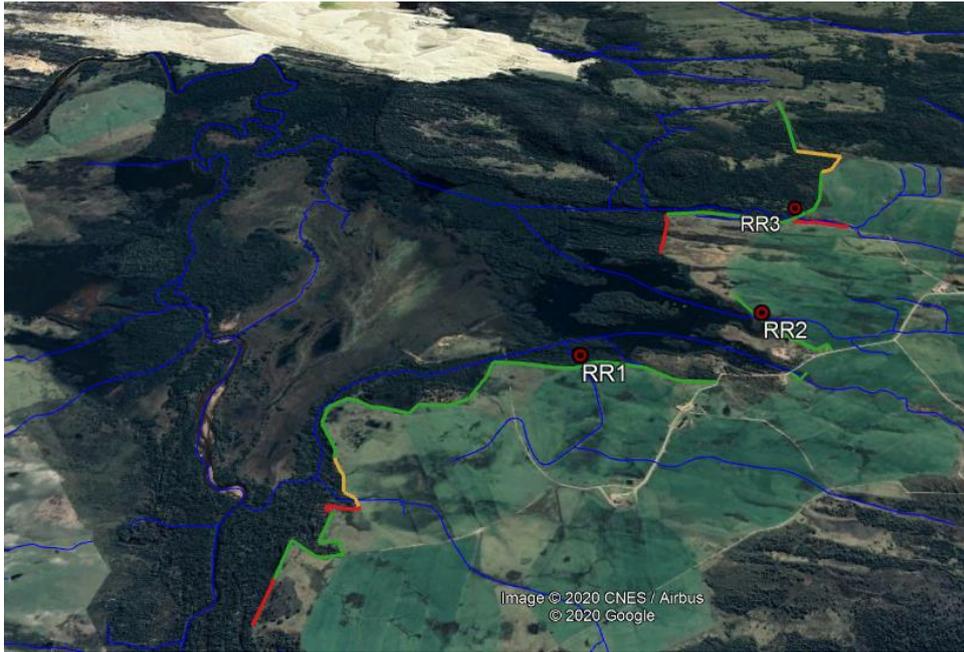
Staff at Enviro-dynamics undertook ground surveys of fencing adjacent to the wetland during site visits in early 2020. Figure 26 shows mapped fencing with fences labelled intact, unknown or disrepair. While the majority of fencing appears to be intact, there are some sections in disrepair that would allow stock to access areas of the wetland.

FIGURE 26. OBSERVED CONDITION OF FENCING ALONG WETLAND BOUNDARY 2020 (GREEN IS INTACT, ORANGE IS UNKNOWN, RED IS DISREPAIR)

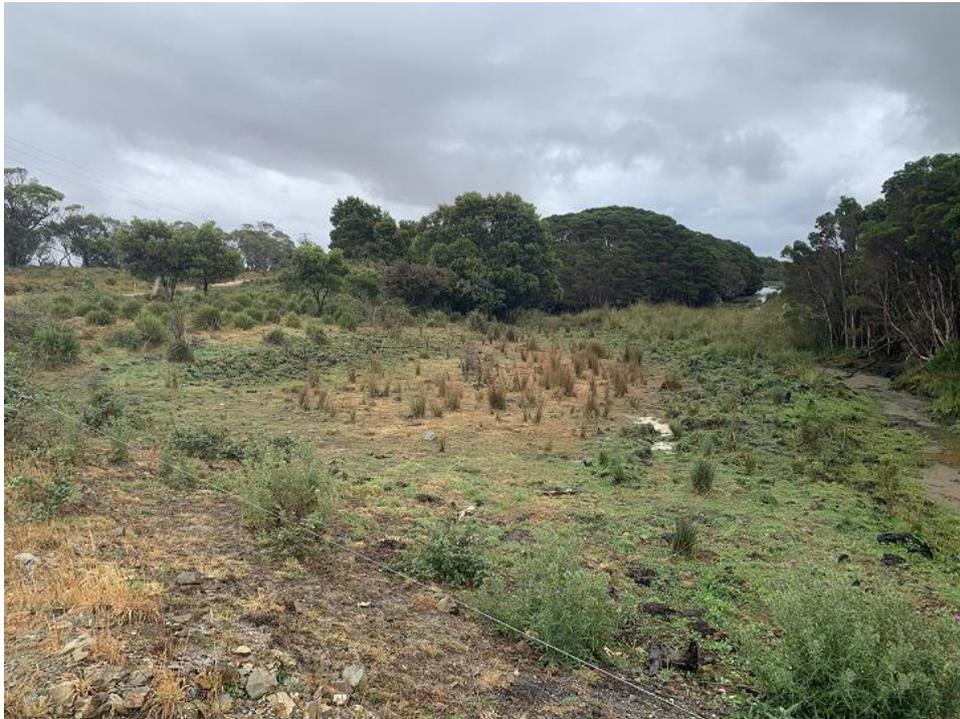
Figure 27 shows a photo taken in January 2020 where there is evidence of stock access to the wetland (visible in the background of the image) behind a fence. Trampling and manure are both seen in close proximity to the wetland and in drainage lines entering the wetland.

FIGURE 27. PHOTO OF AREA ADJACENT TO WETLANDS WITH EVIDENCE OF STOCK ACCESS BEHIND A FENCELINE (TRAMPLING AND MANURE ON RIGHT HAND SIDE OF IMAGE)

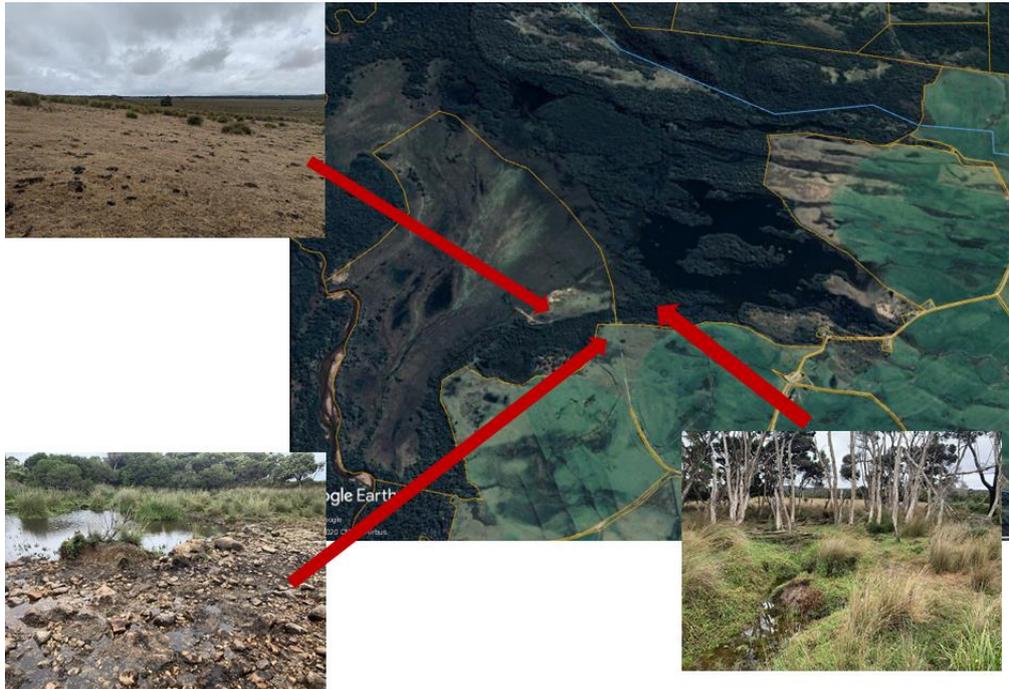
An area of significant ecological values is the Fosters Marshes. This area is periodically grazed. The Marshes appear to be largely fenced but access is gained across a causeway. Access through this entry way is via a gate. A site visit during January 2020 showed evidence of significant stock access with large amounts of manure on the causeway entering the Marshes and on the cleared hillside within the

Marshes as shown in Figure 28. Stock trails and manure were also observed through wet areas of Ti Tree within the Marshes.

FIGURE 28. SIGNS OF STOCK ACCESS IN FOSTERS MARSHES – MANURE ON HILLSIDE, ON STOCK CROSSING INTO MARSHES AND THROUGH TI TREE AND WET AREAS

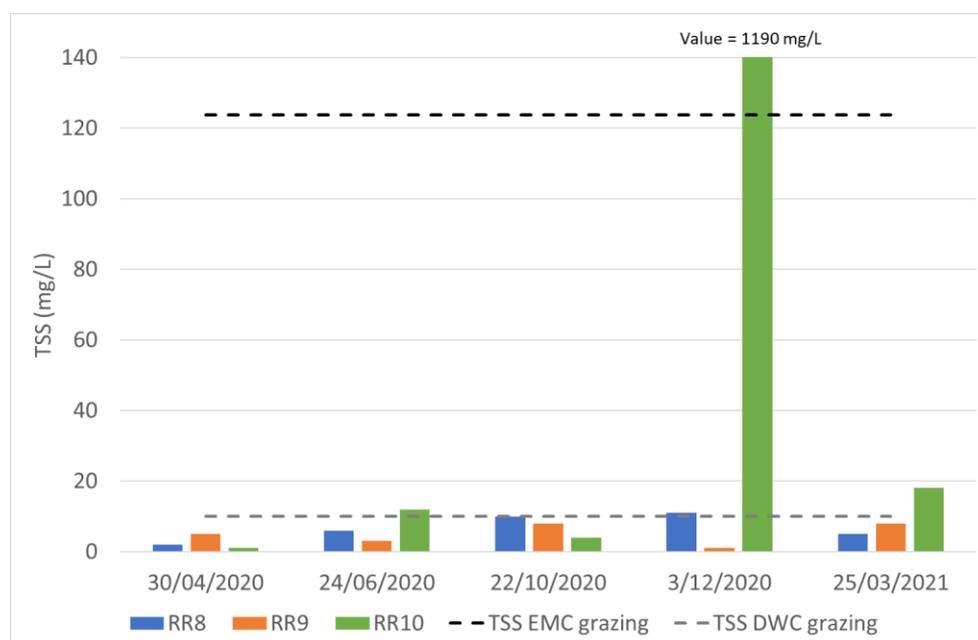
FIGURE 36. MEASURED SUSPENDED SEDIMENT CONCENTRATIONS AT MONITORING SITES ON BOOBYALLA PARK COMPARED TO DRY WEATHER AND EVENT MEAN CONCENTRATIONS FOR TSS ON GRAZING AREAS. NOTE THE Y-AXIS HAS BEEN SET TO A MAXIMUM OF 140 MG/L SUCH THAT THE PEAK VALUE OF 1190 MG/L EXPERIENCED IN DECEMBER 2020 AT RR10 DOES NOT DISPLAY

Figure 36 shows the concentration of TSS at each of the 3 sites on Boobyalla Park. This shows that in general TSS concentrations are very low at all sites, with the exception of RR10 in December 2020, when a peak concentration of 1190mg/L was observed.

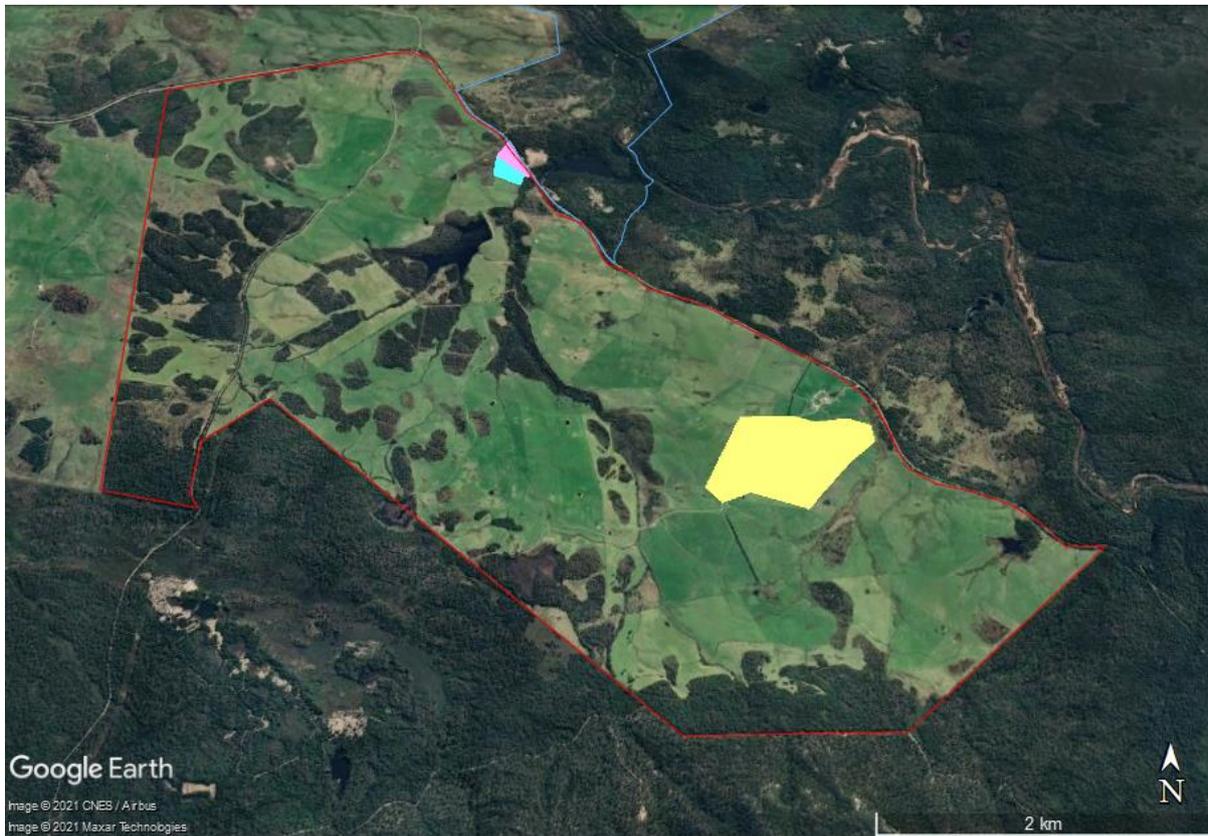
FIGURE 37. AREAS WHERE STOCK ARE CURRENTLY ACCESSING STREAMS ON BOOBYALLA PARK. MAPPED AREA IS ASSUMED CONTRIBUTING PADDOCK AREA WHERE STOCK ARE ABLE TO ACCESS RELEVANT STREAM SECTION

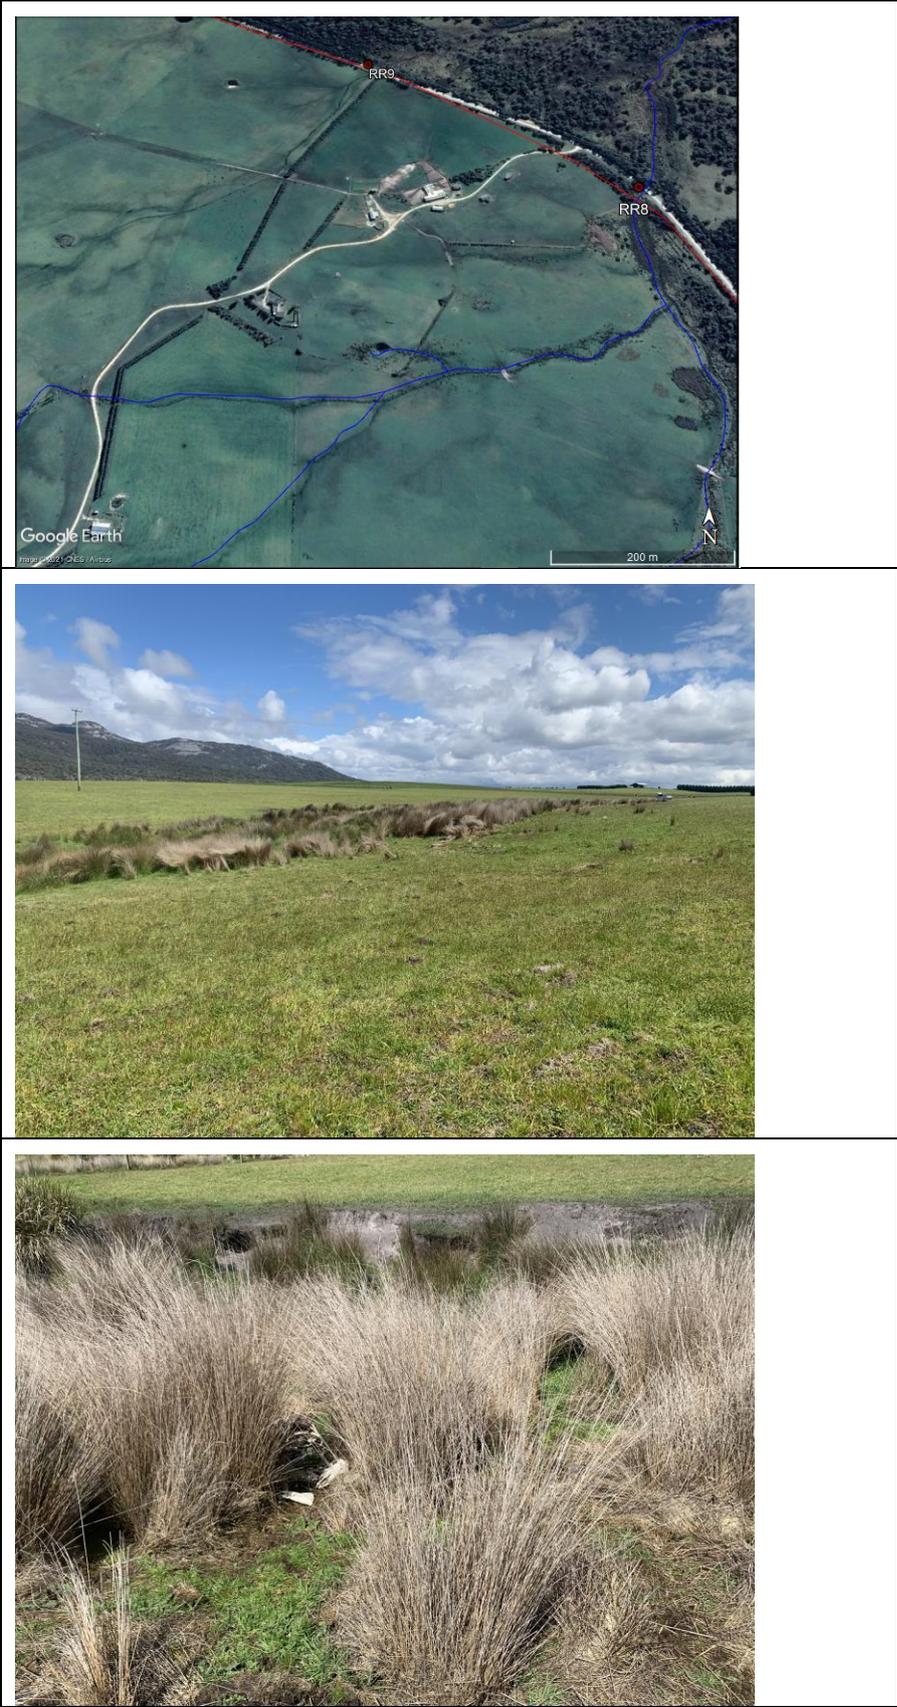
Site 1 is an unnamed tributary to Gincase creek that drains to the wetlands past monitoring site RR8 (see Figure 39). Observations of this creek during the site visit in October 2020 showed that the creek was unfenced and had no riparian vegetation. There were several dead stock in the creek line indicating there may be production benefits to keeping stock out of this section of waterway. Significant levels of algal growth were observed immediately downstream of this tributary in Gincase creek. Observations at RR8 indicated elevated TN and TP at site RR8 in June 2020 with a very high concentration of TP observed. This action would require 1.5km of fencing, 1.5ha of riparian revegetation and gates to allow stock and vehicle crossing between paddocks.

FIGURE 39. SITE 1 – A). LOCATION OF STREAM SECTION B) VIEW LOOKING UPSTREAM ALONG STREAM SECTION C) LOWER SECTION WHERE EVIDENCE OF SEVERAL DEAD SHEEP WAS SEEN

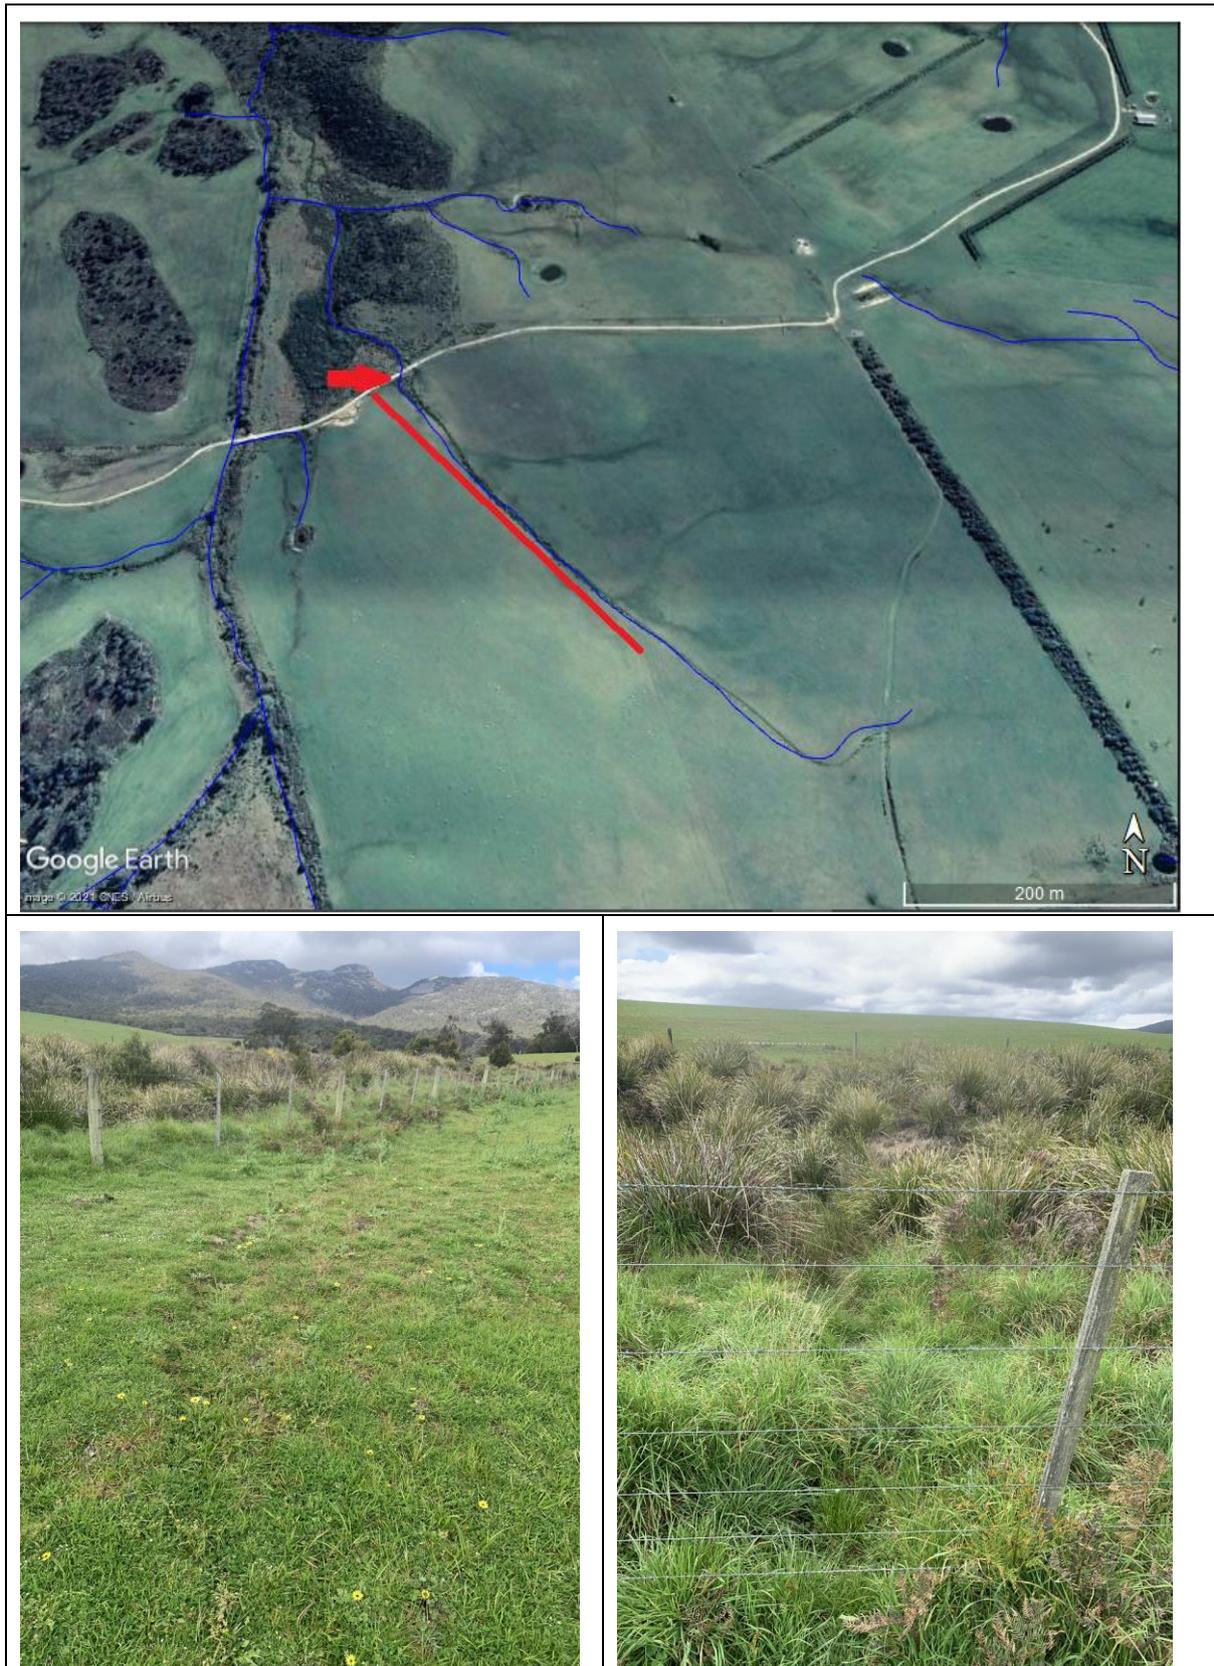
The lower part of Hardwicks creek is fenced and has very substantial vegetated riparian buffers. Site 2 is the top part of Hardwicks creek (see Figure 40). This site is already fenced and has a narrow strip of riparian vegetation. Observations taken during a site visit in October 2020 indicated that despite this there was evidence of nutrient loads in the stream (elevated algal growth). Closer inspection of the site found that the hillside contributing to this stream drains into the corner of this paddock at a point where the riparian buffer is very narrow. There is a natural depression in the paddock at this point which is encouraging runoff to preferentially flow to this part of the paddock. There was evidence of rills where runoff from this hillside is channelising and passing directly through the riparian zone into the stream. A potential management action was identified to widen the riparian buffer to provide a natural filter for flows and nutrients running off at this point. This action would require 350m of fencing (current fences could potentially be repurposed with some new materials and labour required) and revegetation of the widened buffer.

FIGURE 40. SITE 2 – A) LOCATION OF SITE WORKS B) FLOW CHANNEL TAKING CHANNELISED FLOW FROM HILLSIDE C) FLOW CHANNELS FORMED THROUGH NARROW RIPARIAN VEGETATION

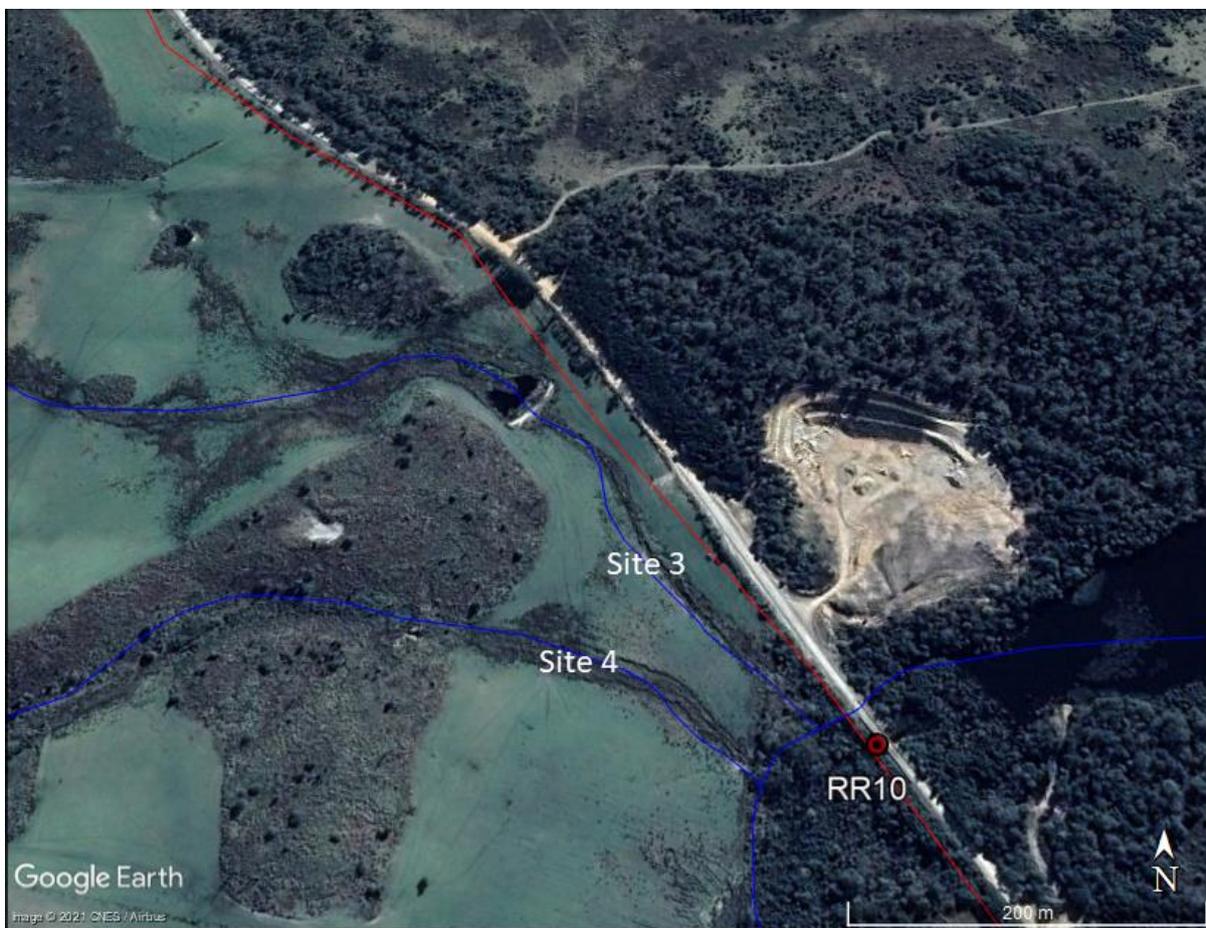
It is also noted that opposite this site there is a significant quarry site within the National Park used to obtain gravel. This quarry is very close to the Lagoon and can be considered a risk to water quality. While this is not managed by Boobyalla park it is suggested that improved management of this site would be desirable, both for the environmental benefits as well as to help address any concerns by the landholder that they are taking significant actions on their own property while a Government managed piece of land poses a more immediate threat. At a minimum creating a wider buffer between the quarry and the lagoon should be considered.

FIGURE 35. LOCATION OF SITES 3 AND 4 – NOTE QUARRY OPPOSITE SITE ON NATIONAL PARK ADJACENT TO HARDWICKES LAGOON
