Why did the crayfish cross the road?

The impacts of culverts on movement of giant freshwater crayfish populations

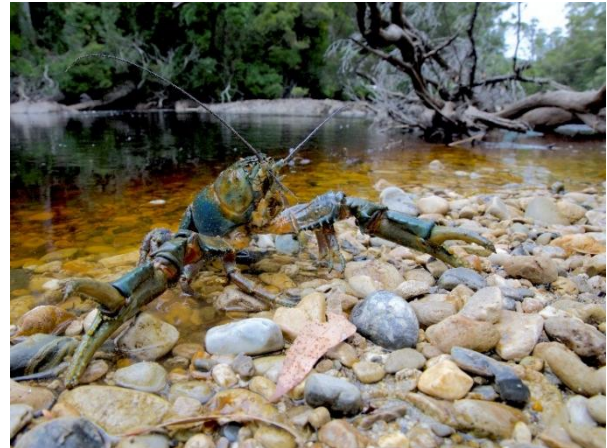
The surface area of rocks in the natural habitat of giant freshwater crayfish help to slow down water velocity and create natural pools for resting places. Image credit: Dan Broun.

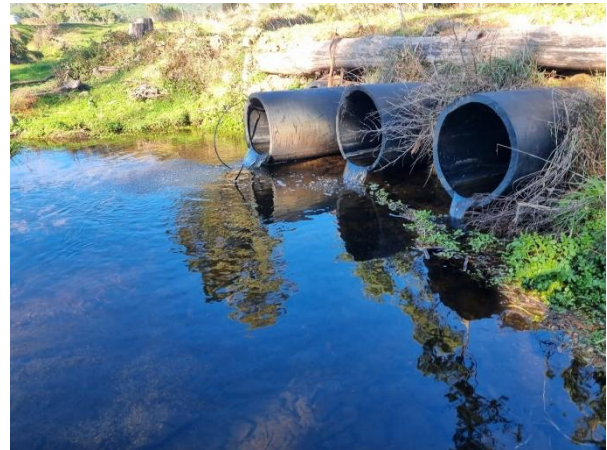
Giant freshwater crayfish are unable to even attempt passage through culverts that are “perched” above the water surface. Image credit: Todd Walsh.

3. Perched steps: If culvert pipes, box culverts, or the concrete slabs that they are positioned on, are “perched” above the stream bed or water surface, it creates a floating step that can be difficult or even impossible to negotiate. For fish species, this creates a dam effect, leaving them stranded upstream or downstream of the culvert. For giant freshwater crayfish, it typically leads to them negotiating the slippery riverbanks to cross the road to the other side.
